INSPECTION OF FALK DRIVE TRANSFER CASE HOUSINGS

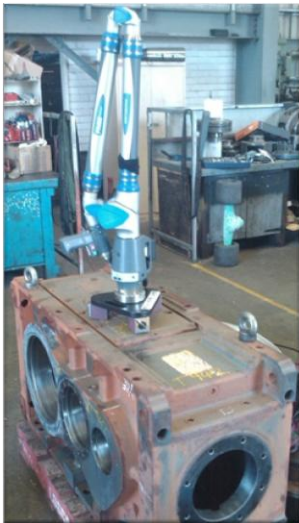
A transfer case housing about to undergo inspection

Primarily of concern were the alignment and location of the bores within the housing which are critical in obtaining acceptable gear tooth contact.

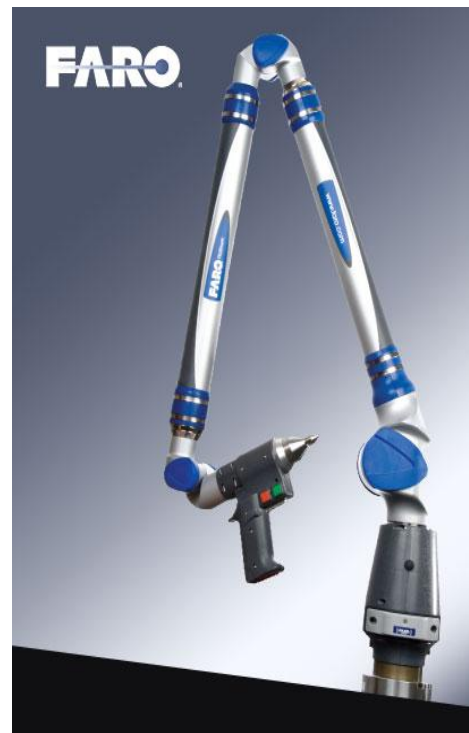
EL ES DE was able to assist Westerfeld Engineering by using their advanced FARO™ Platinum Portable Coordinate Measuring Machine (PCM).

The FARO Platinum 7-axis Portable Coordinate measuring machine

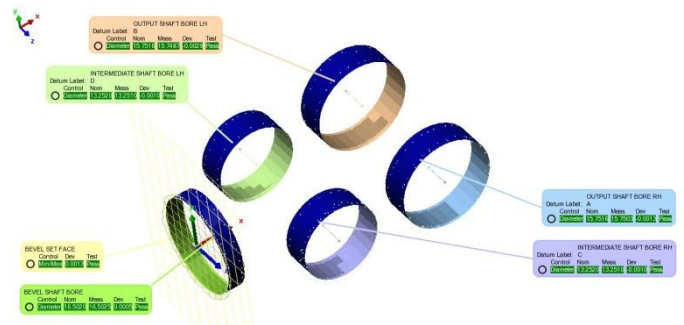
An excerpt from the inspection report detailing the size of the housing bores
